# VEHICLE INSPECTION REPORT

**BX59DFJ**

## Daf LF 45.160

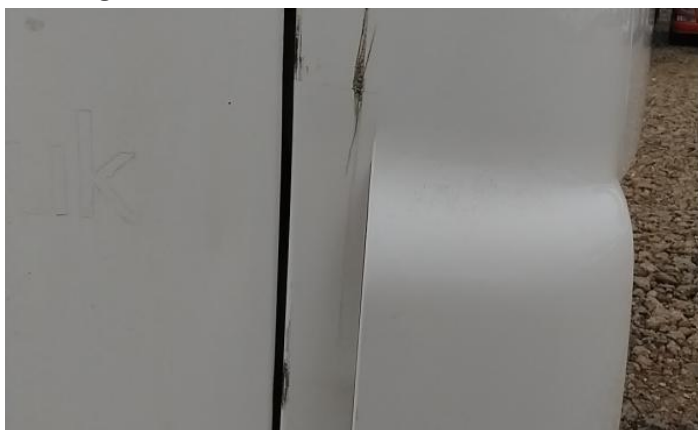
1: Wing osf  
Scratched  
Over 25mm Thru Paint

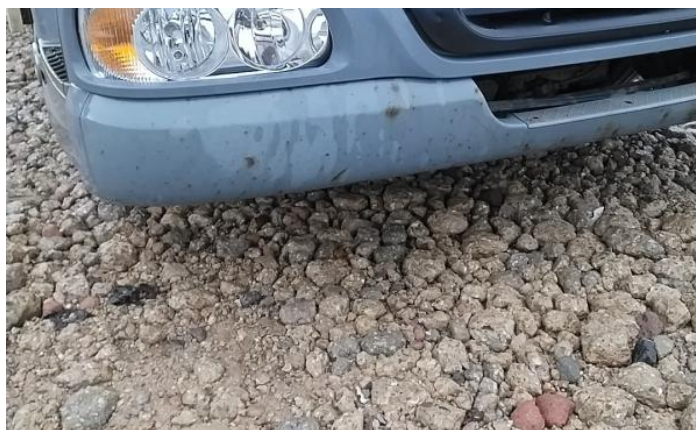
2: Bumper Front  
Rusted  
Over 5mm

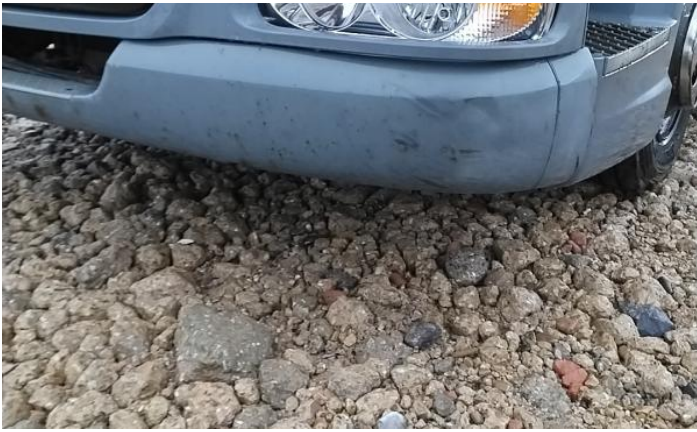
3: Bumper Front  
Dented  
Between 10mm + 30mm

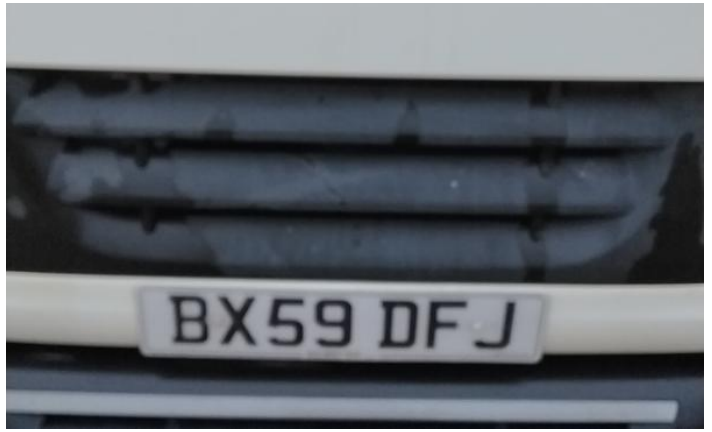
4: Grille Front  
Broken  
Replace

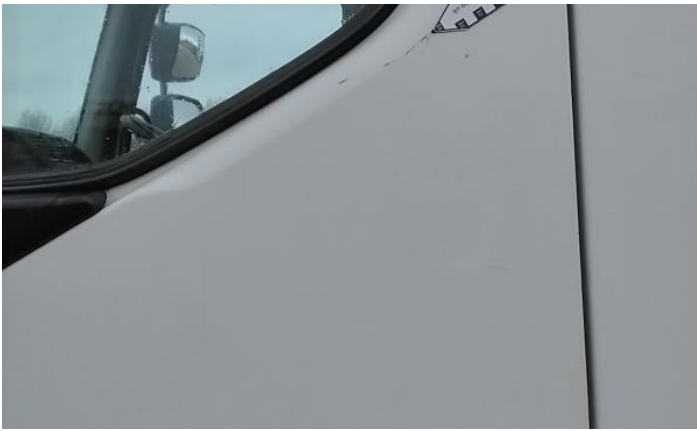
5: Door nsf  
Scratched  
Over 25mm Not Thru Paint

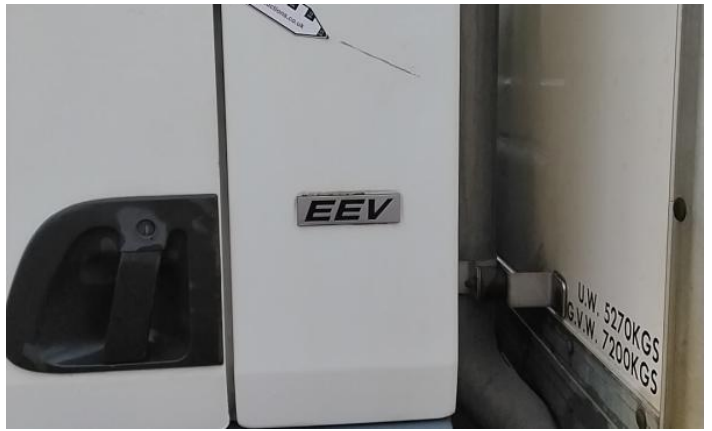
6: B Post ns  
Scratched  
Over 25mm Not Thru Paint

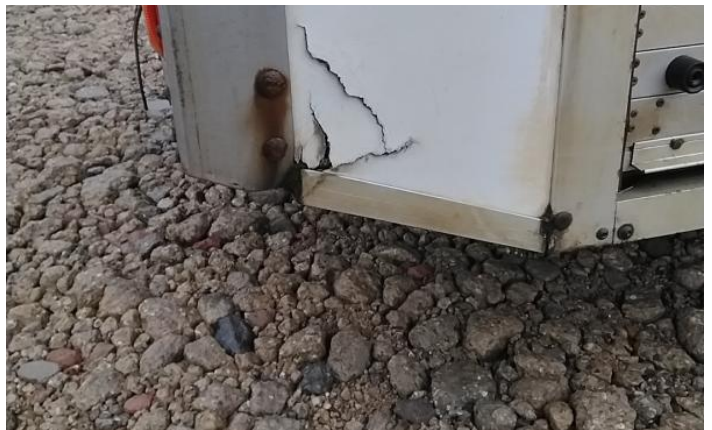
8: Qtr Panel osr  
Cracked  
Replace

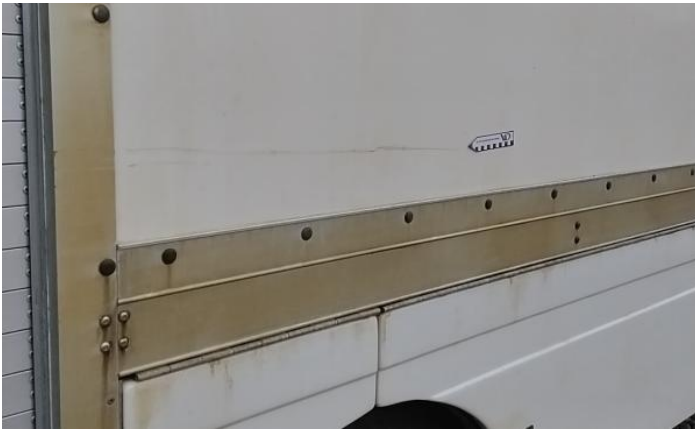
9: Qtr Panel osr  
Scratched  
Over 25mm Not Thru Paint

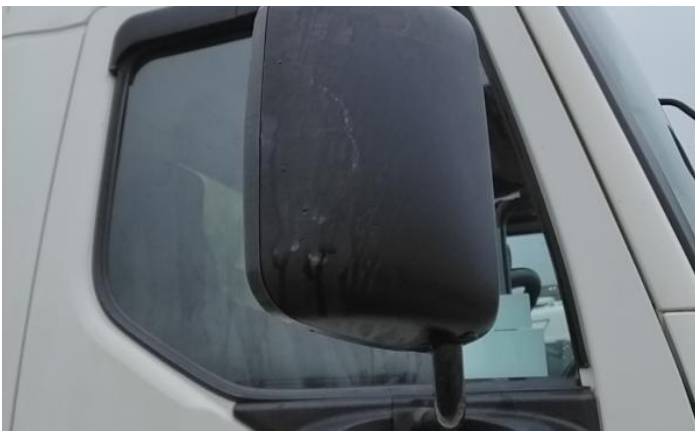
11: Door Mirror Assy osf  
Scuffed (Unpainted)  
Over 100mm
